Steel Structures and Bridges 2012

Timber beams strengthened by carbon – fiber reinforced lamellas

Abstract

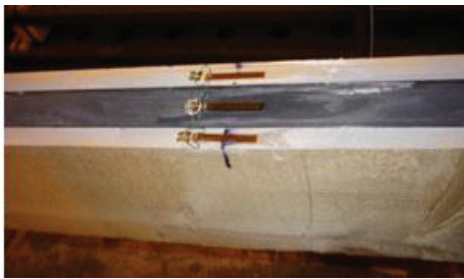
Fig. 1. Lamella and strain gauges bonded to the timber beam (upside down)

The carbon fiber reinforced polymer was applied to the beams in form of lamellas to the tension edge of each beam and was connected on it by special glue based on an epoxy resin, see Fig 1.

The lamellas with the dimension of 50 x 1, 2 mm were used and they were applied to the middle of the width of the timber beam as also visible in the Fig 1. The bonding of the lamella is necessary to be made very thoroughly (this is provided by the supplier of the lamellas) and the glue needs a week of hardening to obtain the correct properties.

As was mentioned above the stress on the borders of materials between the layers timber – lamella (realized by the layer of epoxy glue) was measured. The gauges were bonded to the beam as is visible in the Fig. 1. As results of the gauges we observed the values of the strain ε . Calculations based on these values were worked out. First we calculated the theoretical value of ratio of modulus of elasticity of timber to modulus of elasticity of carbon n . In the case of timber the modulus of $10 \cdot 10^9$ [Pa] was considered and in the case of carbon the modulus of $155 \cdot 10^9$ [Pa] was considered. The calculation of n follows.

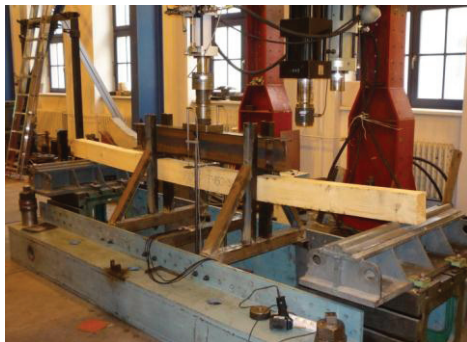
Fig. 2. Test arrangement

The beams were tested with the theoretical span of 3, 0 m and 4, 0 m as mentioned above. All the beams acted as simple girders (supports were realized by special supporting steel pads) and were loaded by a hydraulic press. The force was transmitted to the beam through a steel cross beam. The experiments were going on as a four – point bending, see Fig 2.

A few words about the loading system were mentioned yet. The force was transferred to the timber beam via the steel cross beam and this one was located on special steel pads (the supports of the beam were realized by like pads) which acted against high value of contact stress in the timber.

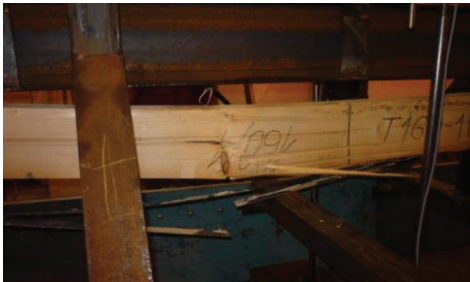
Fig. 3. Separation of the lamella

The connection turned out as of very high strength but, as mentioned above, the joint between the layers lamella – glue was broken very often. The separation of the lamella occurred in a case of many experiments but usually not in all range of the span. If the lamella was separated in some parts a piece of timber material was pulled out of the cross section, see Fig 3.
